**A Comparison of Afghanistan, Yuma, AZ, and Manufactured Sands Melted on  
EB-PVD Thermal Barrier Coatings**

THESIS

AFIT-ENY-T-14-S-18

**AIR FORCE INSTITUTE OF TECHNOLOGY**

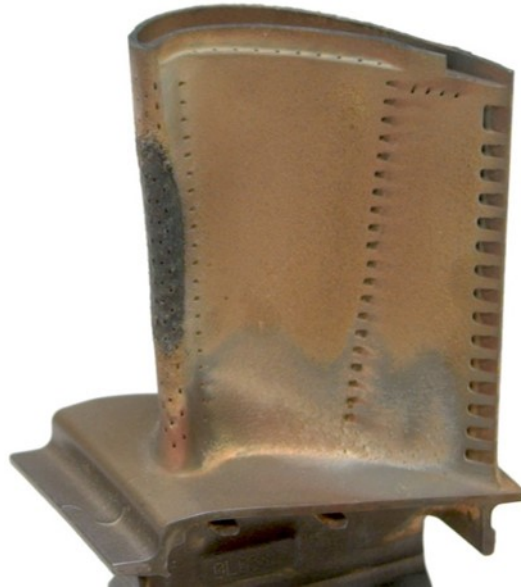
**Figure 17: Turbine engine blade coated with CMAS**

Figure 17. This molten glass attack is referred to as CMAS (calcium-magnesium-alumina-silicate) attack on TBCs.

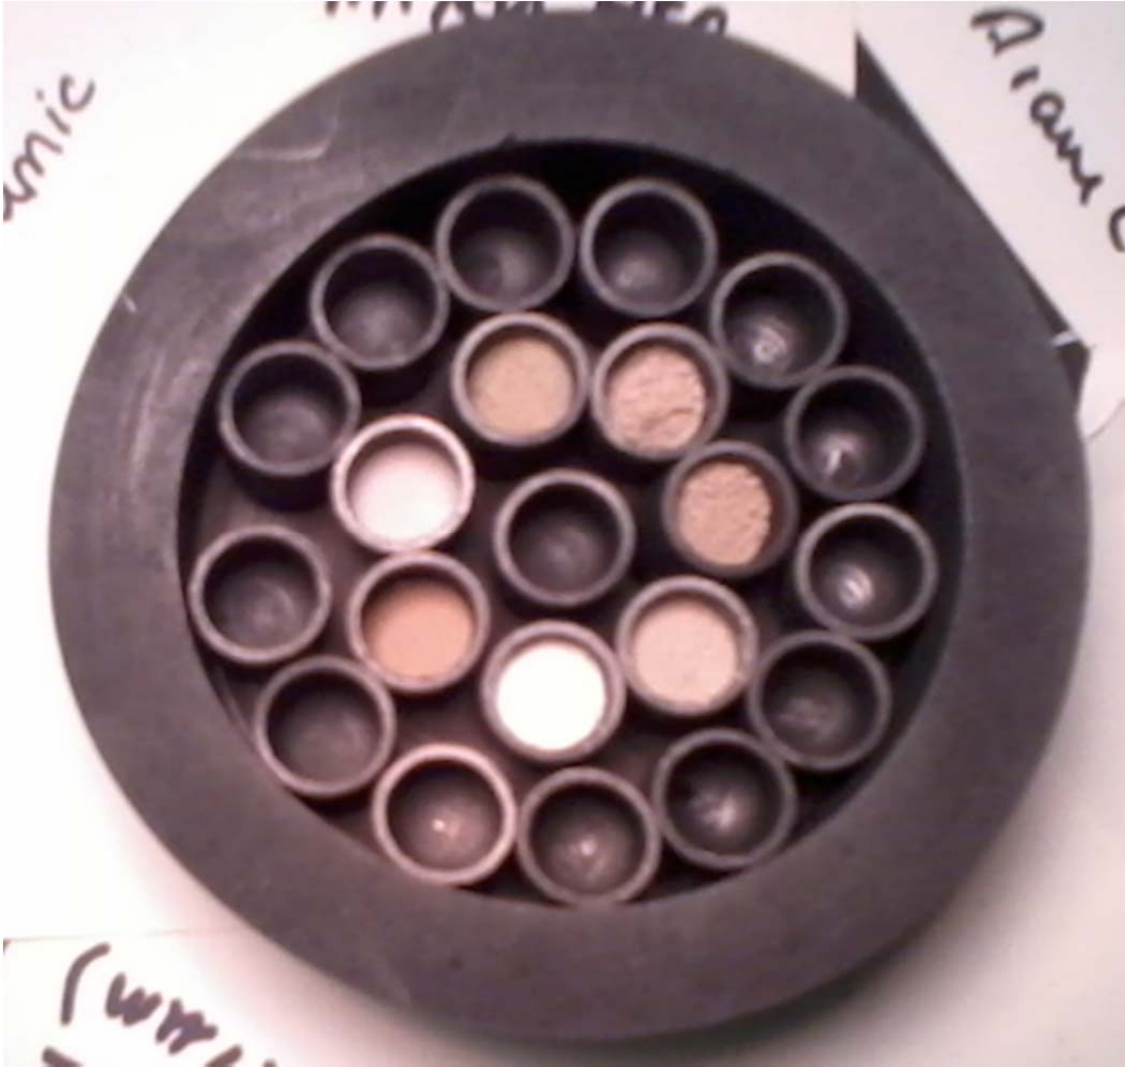
**Figure 18: Graphite Crucible with LECO® graphite crucibles containing sand.**

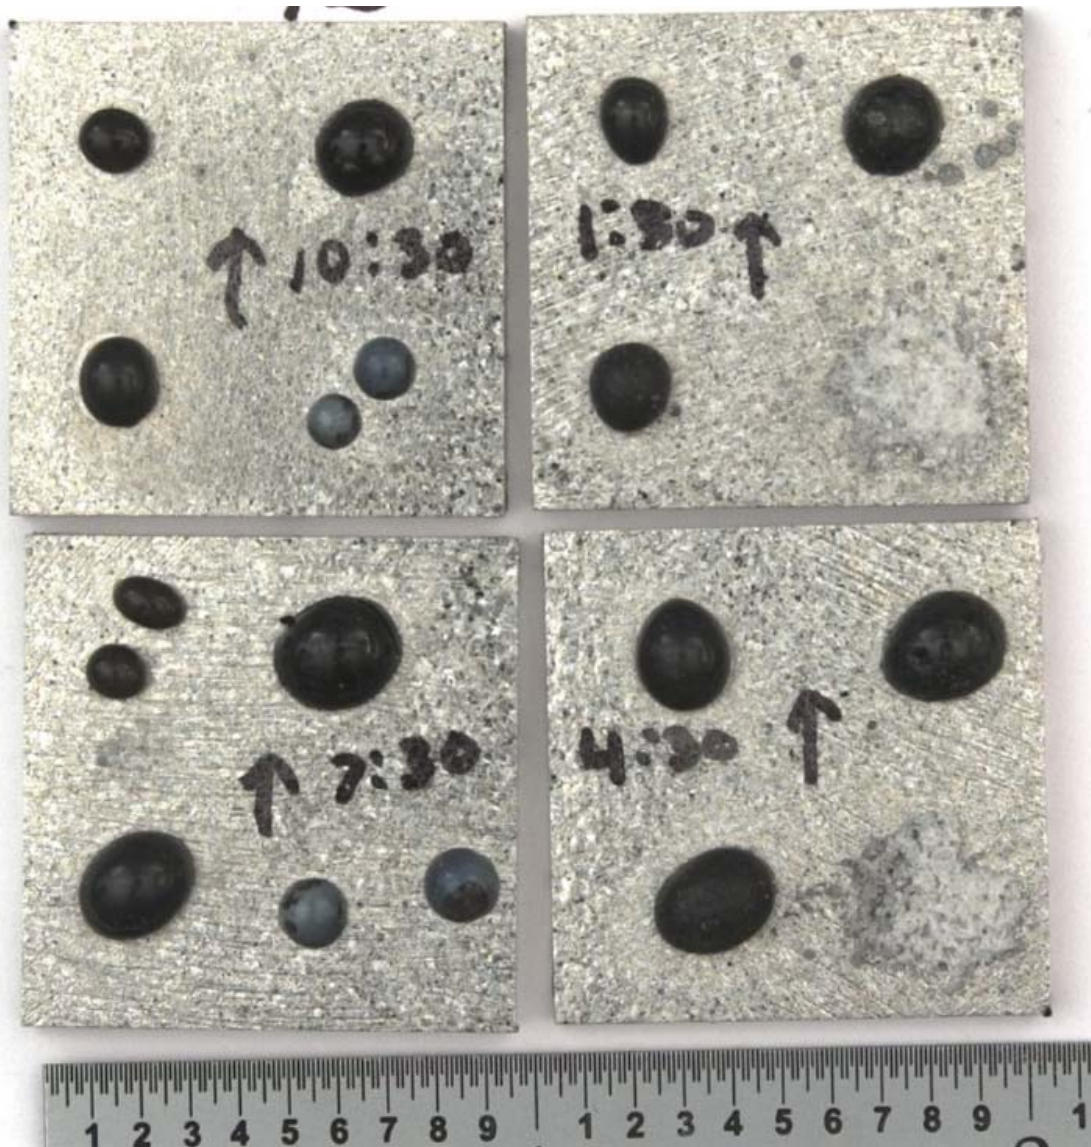
**Figure 19: Electro-Plated Nickel superalloy square substrates.**

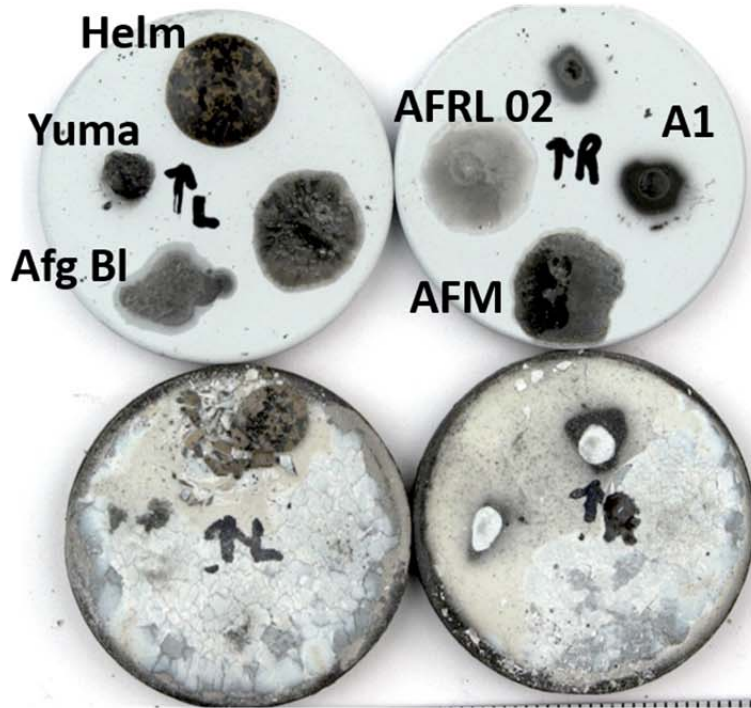
Figure 34: Wetting behavior of Phase 3 heated on TBCs at 1300 °C.

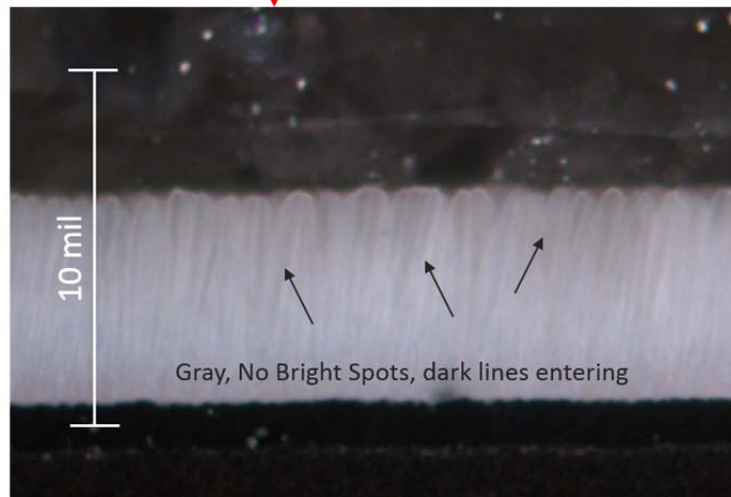
**Figure 36: Optical cross-section of A1 and AFM sample heated to 1200 °C by dark field microscopy. A1 sample has a gradual boundary indicating where sample wet the surface. AFM sample presents colors typical of**

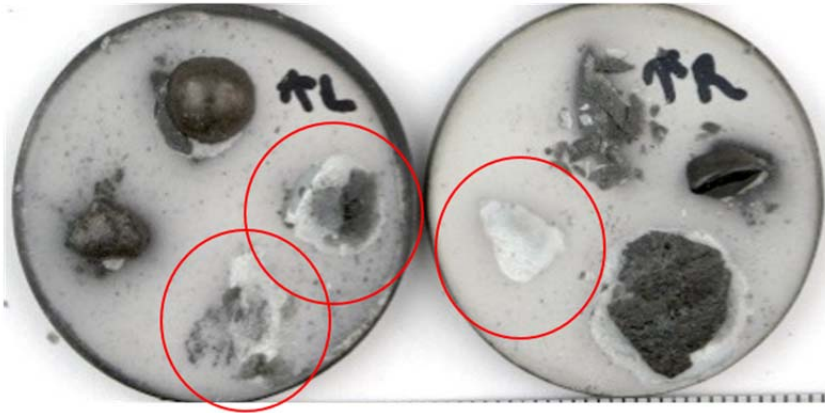
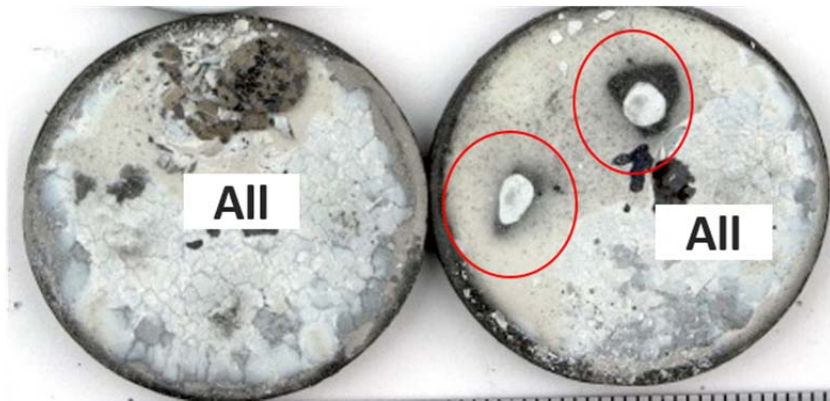
**Mfg B Buttons heated to 1300 °C**

**Figure 48: Button B illustrates missing TBC, indicated by the red circles, and in “All” regions.**
